Office Chair arm adjustment lever.

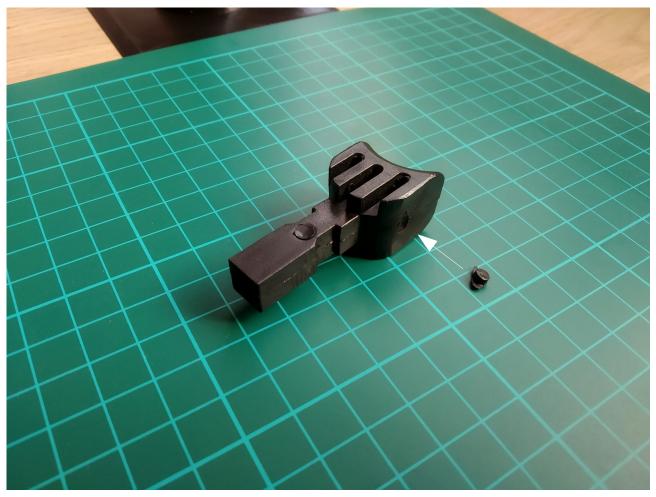
Figure 1: Overview

This arm adjustment pin fell out of my chair because two plastic locking pins broke off. One of the broken pins can be seen in the figure 1. it used to be stuck to the side of the lever.

The lever is made of a quite a soft feeling plastic, it is not very neatly made with a lot of fabrication marks on the square end. The rounded end feels very soft and is where the user interacts with it.

It has a hole in the square end where a spring needs to fit in.
